Documentary: MS Estonia has a large hole in the hull

By Silver Tambur / September 28, 2020

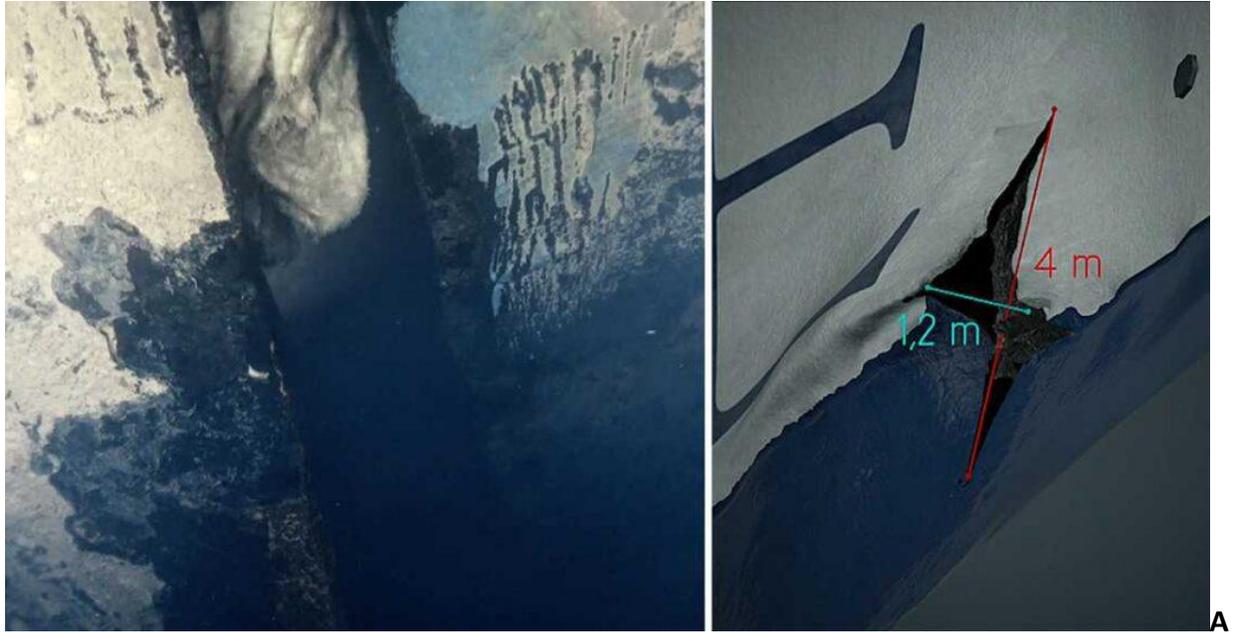
the documentary. Their footage revealed four metres high and 1,2 metres wide hole in the ferry's hull, on the starboard side – that until now, has never been mentioned or documented.

A hole in the MS Estonia hull as revealed by the footage in the new documentary by Henrik Evertsson. Photo by Aftonbladet.

Writing about the documentary, the Swedish newspaper Aftonbladet said the hole was previously partially hidden in the seabed.

According to the released footage, it is not clear whether the hole appeared before or after the ferry sank. Some experts have already ruled out an explosion, but others say it could have been caused by a collision. Jorgen Amdahl, a professor of marine technology at the Norwegian University of Science and Technology, said in the documentary that “it is not ruled out the damage played a big role in the sinking”.
